# Manhole Inspection Summary

Manhole # S15A1\_016MH

**Inspection** ☐ Is Incomplete Rating: **2) Good**

**Location** Address: **1310 gloster av**

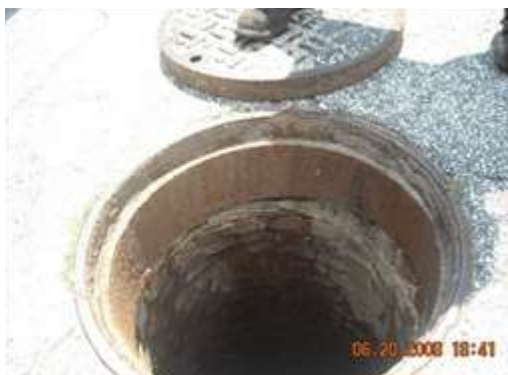
Misc

Subject To Ponding: **Sheeting**

inflow evidence from sheeting

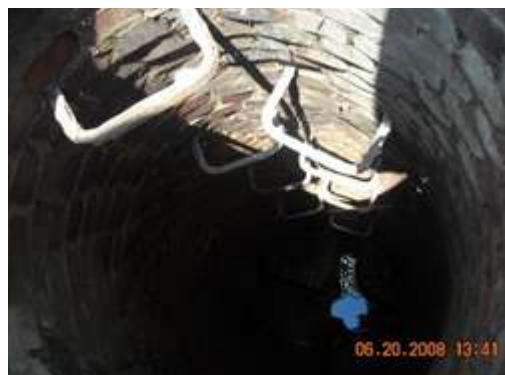
Defect 2

Count: **9** Missing: **0** ☒ Corroded

corroded steps

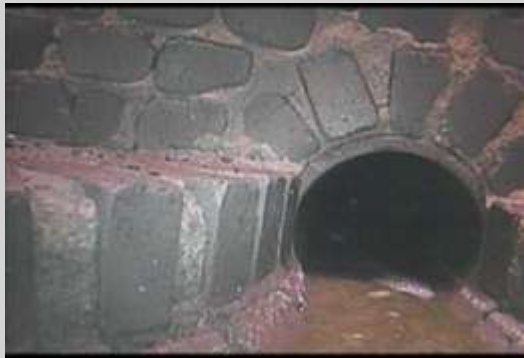
12 O'Clock Outflow

Pipe Height: **8.4** (in.) Rod and Bar (Angled)  
Pipe Material: **Clay** ☐ Pipe Lined  
Invert Depth: **14.90** (ft.) Flow Characteristics: **Slow**  
Deposits: ☒ None ☐ Mud ☐ Sludge ☐ Debris ☐ Grease  
Silt Depth: **0** (in.) Deposits Extent:  
Infiltration: **None** Pipe Seal Cond: **Sound**

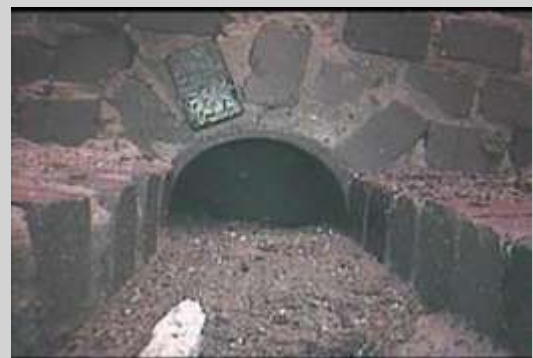
Drop In @ 3 O'Clock

Connects To: **Stub connection / abandoned**

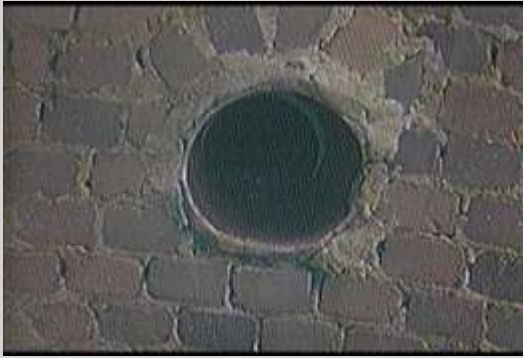
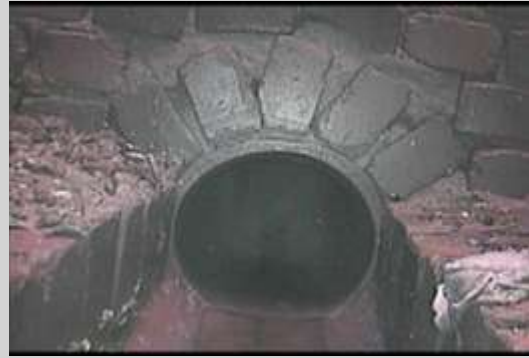
Infiltration: **None** Pipe Seal Cond: **Sound**

Drop: **Outside** Rod and Bar

Drop Condition: **Open**

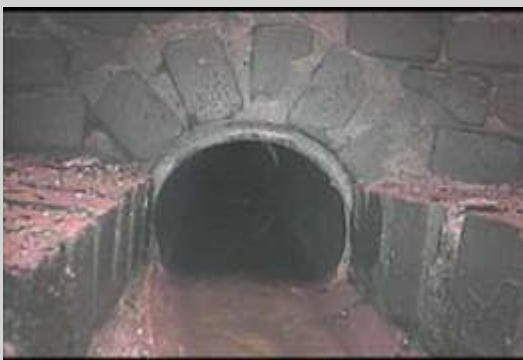
9 O'Clock Inflow

Infiltration: **None** Pipe Seal Cond: **Sound**

Connects To: **Dead End**
